EVALUATING ALL-WEATHER PAVEMENT MARKINGS IN ILLINOIS: VOLUME 1

Research Report No. FHWA-ICT-15-018

**Evaluating All-Weather Pavement Markings
and Lab Methods to Simulate Field Exposure**

December 2015

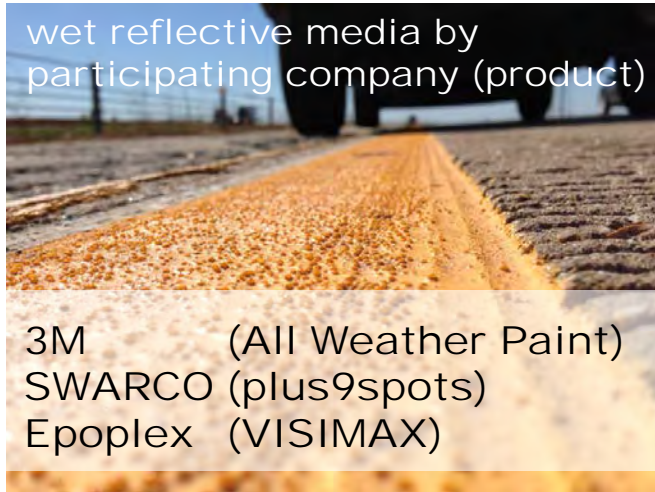
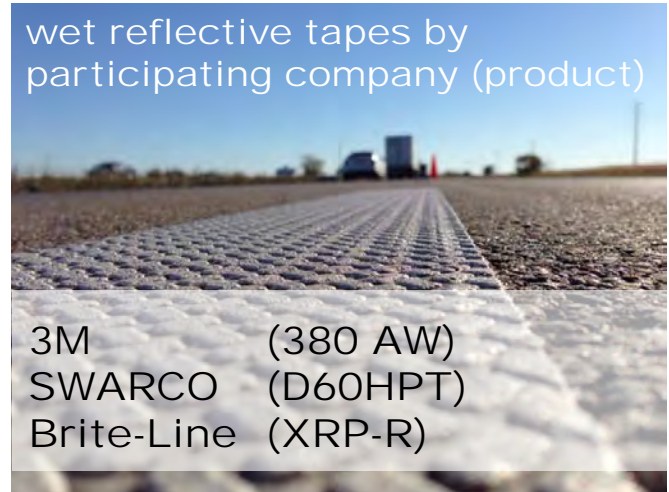
Figure 2.1 Vendor participation and all-weather media and tape products.

The TRP was interested in seeking out the range of market-ready all-weather wet reflective media available for evaluation in this research project. The research team initiated dialogue with the pavement marking industry and ultimately decided to hold an open-invitation, IDOT-sponsored vendor conference call. This call provided each vendor with an overview of the research objectives in addition to information specific to their participation. The vendor call meeting information provided is noted below, and Figure 2.1 shows the vendor participation and products.

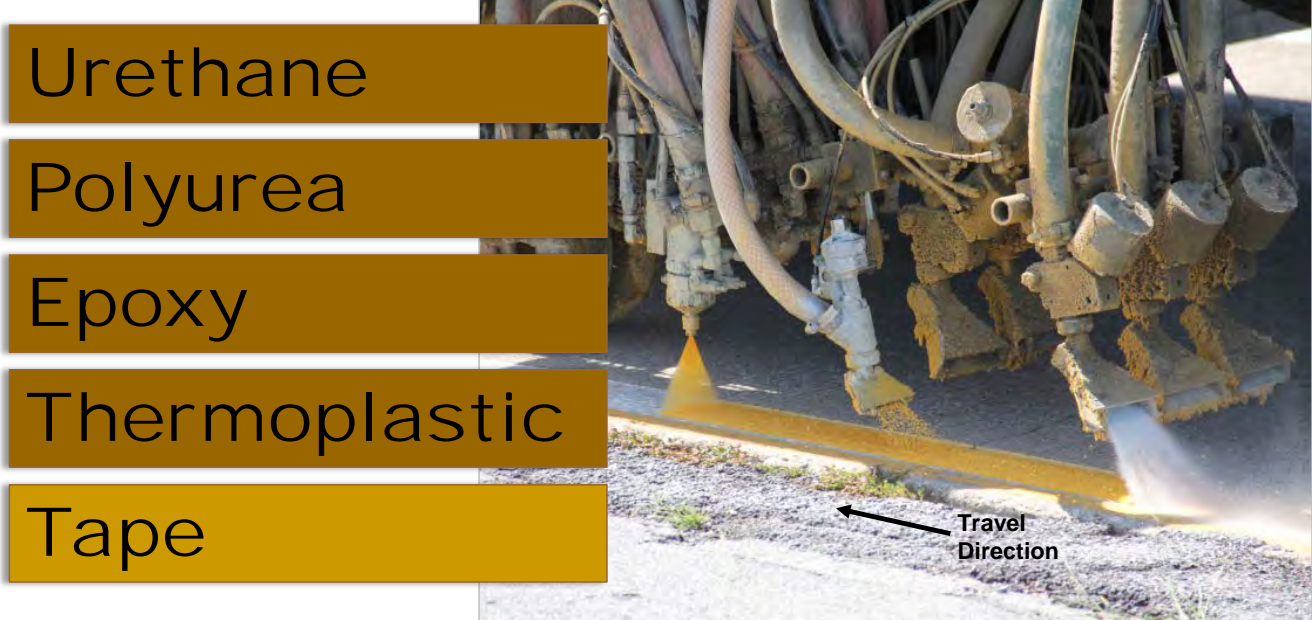
Figure 2.2 Marking materials and bead gun arrangement.

The wet reflective media were delivered to the line prior to the standard IDOT beads, as shown in the photo above. All liquid marking products were placed within a 60 mil groove with the exception of thermoplastic which was installed within a 125 mil groove. The liquid pavement marking products were placed on several types of roadway surfaces (PCC and ACC).

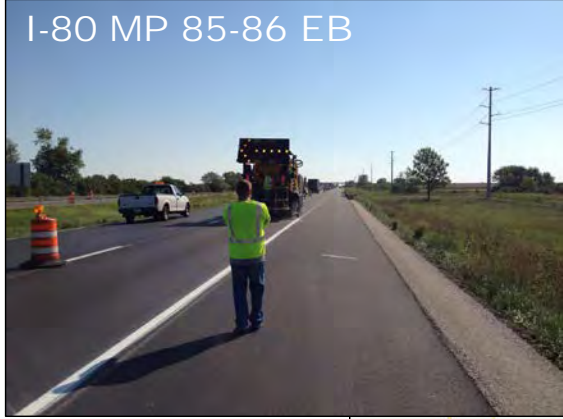
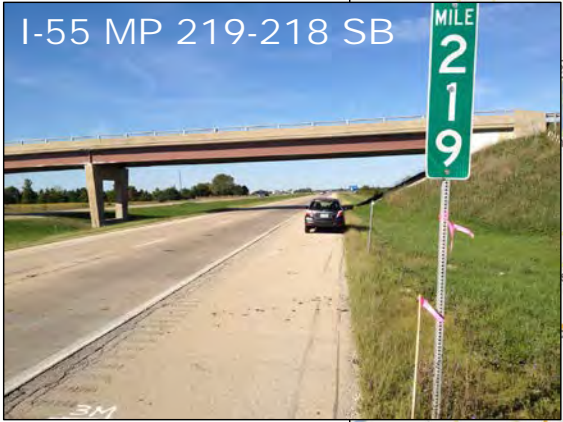
Figure 2.5 Test deck installation photo and locations for I-80 and I-55.

The I-80 test deck was part of a major resurfacing effort and included three different wet reflective tape products on the white skip line and three different all-weather products on the white edge line. The yellow edge line was not included because of issues with contractor staging. The segment lengths per product varied because this project had to be completed under construction staging conditions.

The I-55 test deck was installed on the existing Portland cement concrete (PCC) surface and included all-weather markings for the yellow edge, white skip, and white edge lines with equal one-third-mile segments for each product.

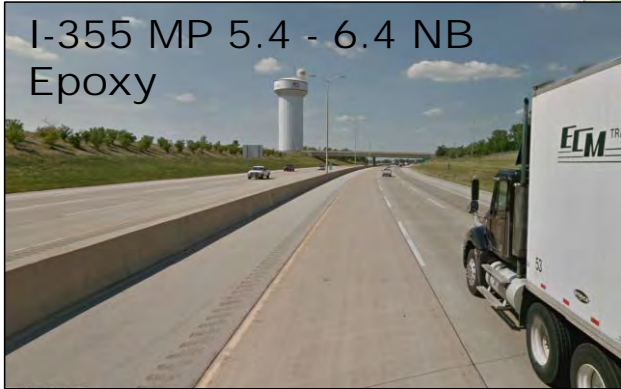
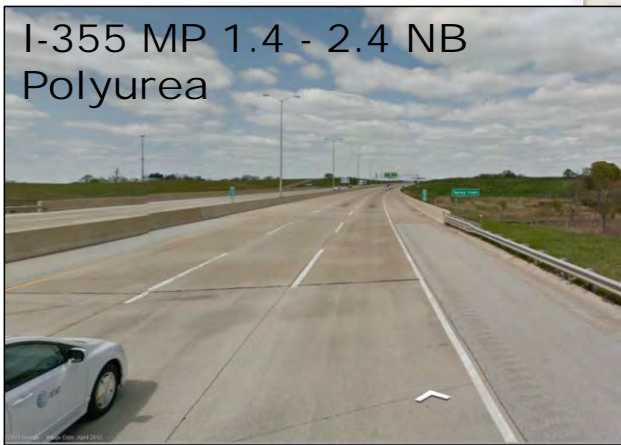
Figure 2.7 Test deck installation photo and locations for the I-355 tollway.

Figure 2.7 provides a map and photos showing the test sections and direction of travel for both sections receiving the all-weather markings along the I-355 tollway. Figure 2.8 provides the details specific to the location where each test product was placed, by line type and test deck segment.

The I-355 test deck markings were placed over an existing PCC roadway; however, the grooving operation was already completed for this project. The polyurea and epoxy decks were laid out in the same manner, by product and line type. This included test materials for the white edge line, the adjacent white skip line, and the yellow edge line. To minimize installation time, and given that there are two white skip lines on this four-lane road, the white skip line adjacent to the yellow edge line was not striped as a part of this study. Because of traffic demands, the materials were installed at night.

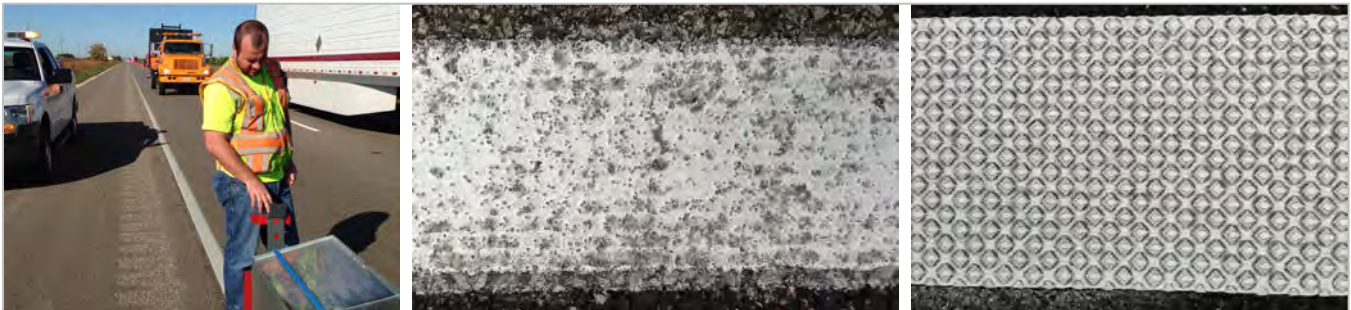
Figure 3.1 Taking a retroreflectivity (continuous wetting, left) reading on I-80 along with marking presence images for the white edge line (center) and centerline skip (right).

District 3 staff provided traffic control while the white edge and white skip lines were being measured. Initial measurements were completed in November 2012. Additional measurements were made in October 2013 (1 year) and June 2014 (2-year reading, or after two winters). Scheduling for all readings was a major effort and subject to district staff availability and traffic conditions. Figure 3.1 includes a few images from one of the measurement activities.

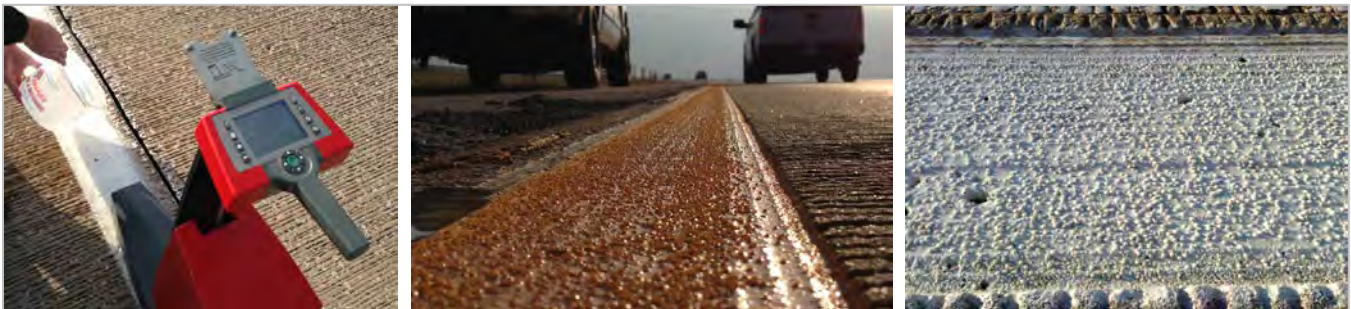
Figure 3.2 Taking a retroreflectivity (recovery, left) reading on I-55 along with marking presence images for the yellow edge line (center) and white edge line (right).

District 3 staff also provided traffic control for measuring the white edge, white skip, and yellow edge lines. This roadway was measured at the same times as I-80. Figure 3.2 includes a few images from one of those measurement activities.

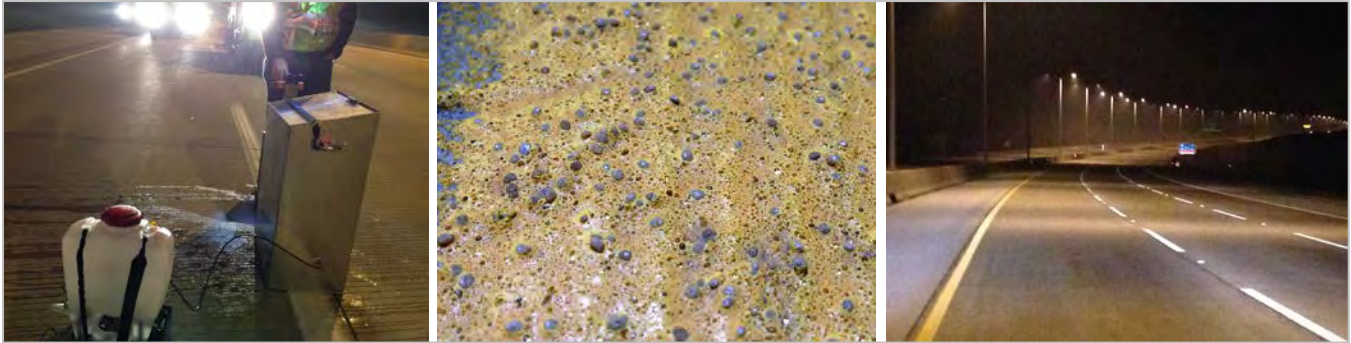
Figure 3.3 Taking a retroreflectivity (continuous wetting, left) reading on I-355 along with marking presence images for the yellow edge line (center) and general photo of all lines (right).

The Tollway's contractor provided traffic control while the two test decks on I-355 (all at night) were being measured. The white edge, white skip, and yellow edge lines were each measured. Initial measurements were completed in October 2013 followed by September 2014 (1 year). No additional measurements were taken beyond the 1-year time period because of the costs associated with obtaining the measurements and the wet retroreflective performance observed. Figure 3.3 includes a few images from one of the measurements.

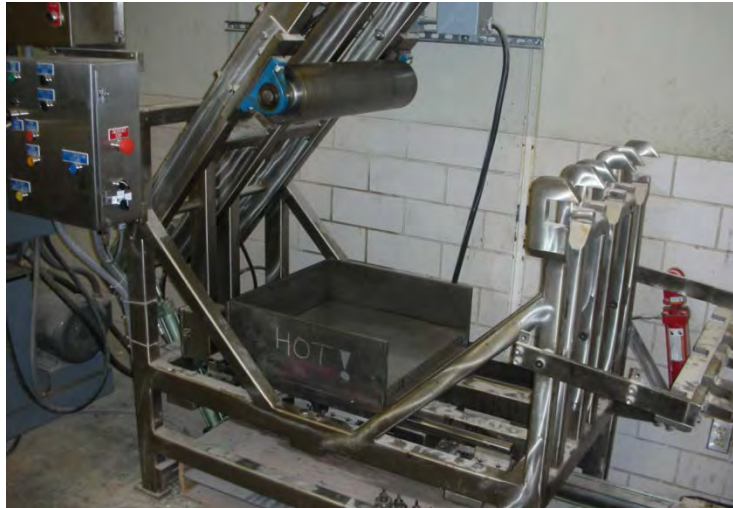
Figure 4.1 Linear kneading compactor for preparing asphalt slabs.

To conduct the initial lab testing, the researchers first needed to produce pavement marking samples. The researchers produced pavement marking sample substrates out of typical roadway materials. These materials were cast concrete and asphalt made with a kneading compactor (Figure 4.1).

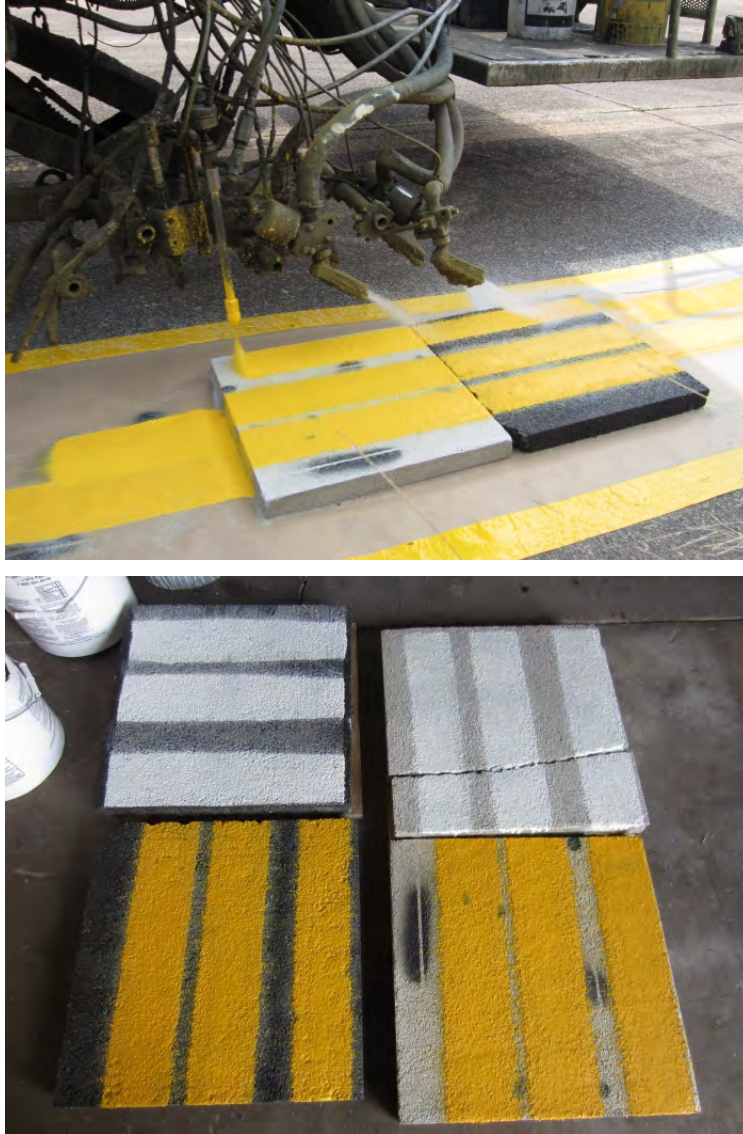
Figure 4.2 Pavement marking samples.

The researchers striped over the substrate slabs with a material similar to what was installed on the field test decks. The markings were white and yellow Epoplex LS50 epoxy with a double drop of AASHTO M-247 Type I and Type IV beads. Three stripes were put on each slab to allow for more flexibility in conducting the initial accelerated wear testing. Figure 4.2 provides an image of the slabs being striped and of the four striped slabs.

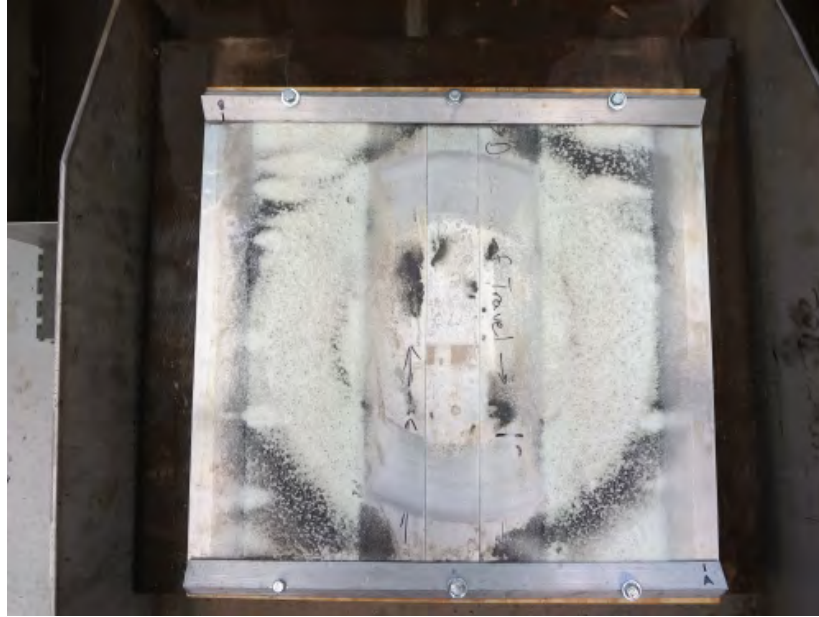
The pavement marking samples were cut using a band saw so that they would fit into the testing jig that was placed in the circular track polishing machine. Two samples were placed into the jig at the same time. The samples were marked with arrows to indicate the installation direction of the markings in the field. The markings were placed into the jig so that the wearing would occur in the direction that the markings were striped, which would be the same way they would be worn in the field by traffic. Not all of the markings were applied to the center of the substrate material. To account for the different positions, additional aluminum spacer strips were placed between the two samples in the jig. These spacers were used so that the markings were always in the same position under the accelerated wear device. This resulted in the marking samples all receiving wear centered along the marking sample. Figure 4.5 shows two marking samples on the test jig after testing. The wear path of the wheels is well defined on the sample.

Figure 4.5 Aluminum sample plates during testing.

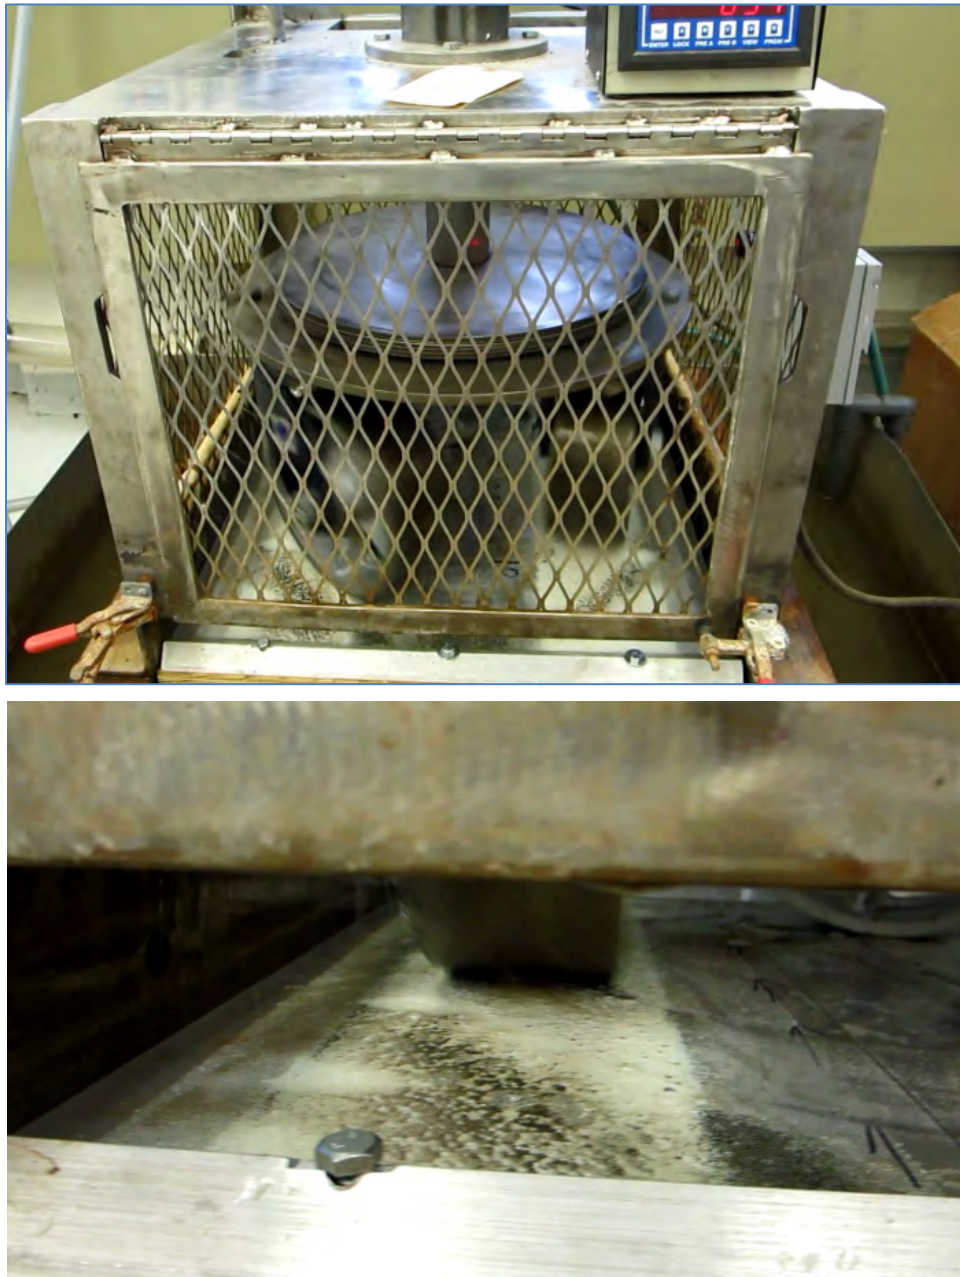
Figure 4.6 Accelerated wearing of samples from test deck.

portion of the field samples for the markings that had not yet received the accelerated wearing. The performance of the samples was evaluated after 0, 250, and 500 cycles.
